Mobile Pentium® II Processor Specification Update

Release Date: July 1999

Order Number: 243887-012

The Mobile Pentium® II processor or the Intel® Pentium® II Processor Mobile Module may contain design defects or errors known as errata which may cause the product to deviate from published specifications. Current characterized errata are documented in this Specification Update.

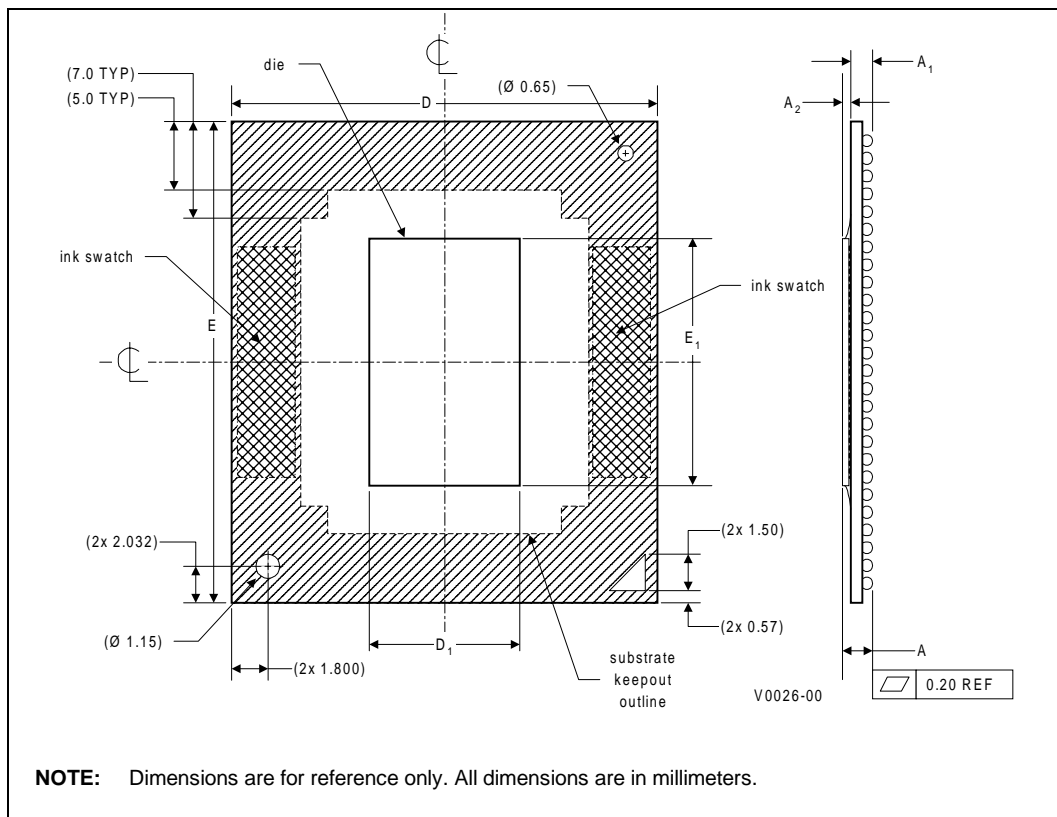
Figure 5.3. Surface-Mount BGA1 Package—Top and Side View

The following table and figures show the updated mechanical specifications for the BGA1 package, listed as Table 5.2, Figure 5.3 and Figure 5.4, respectively, in the *Mobile Pentium® II Processor in BGA Package at 366 MHz, 333 MHz, 300PE MHz, and 266PE MHz* datasheet.

1. The number shown here is different from that in last month's specification update. The maximum reference number is used.
